Protection of Tsunami Affected Coastal Areas by Establishing
Bio - shield through People's Participation

Seethalakshmi K. K
Raveendran V. P
Balagopalan M

Kerala Forest Research Institute
Peechi, Thrissur, Kerala

KFRI Research Report No. 362

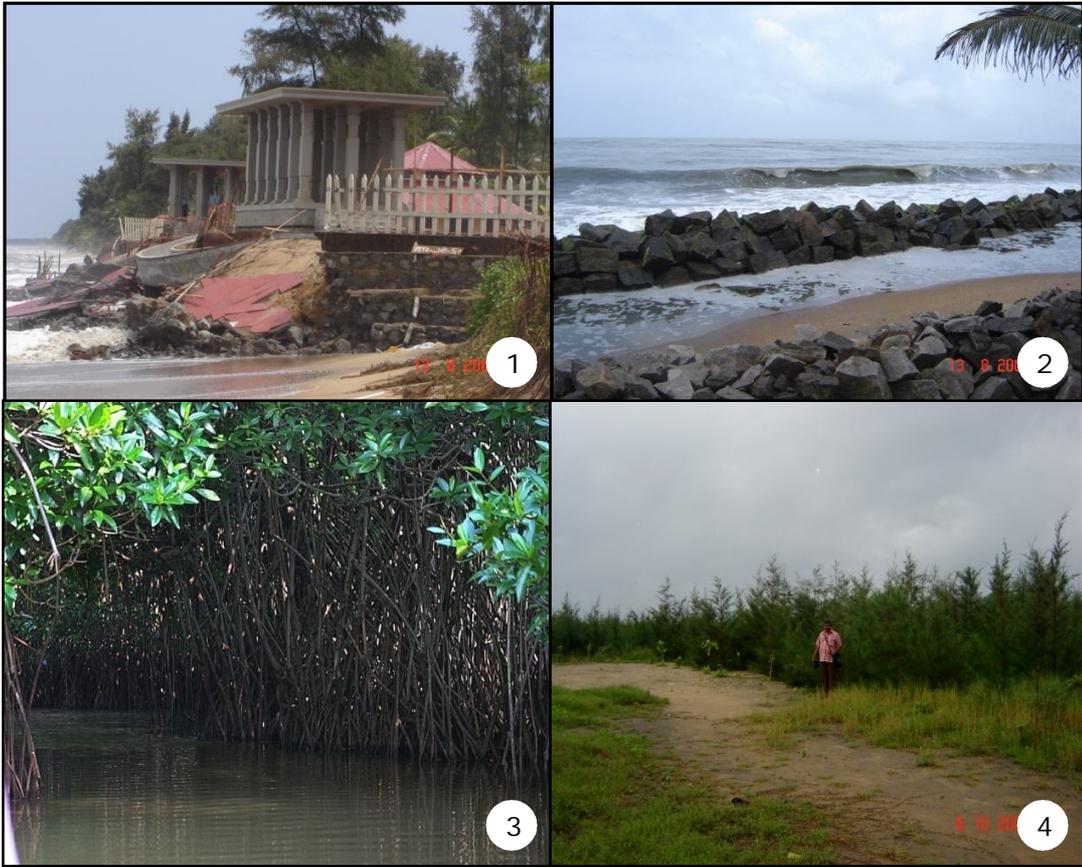
Plate 1. 1. Building damaged due to waves 2. A part of the damaged sea wall 3. A view of the mangrove vegetation 4. Shelter belt with *Casuarina equisetifolia*

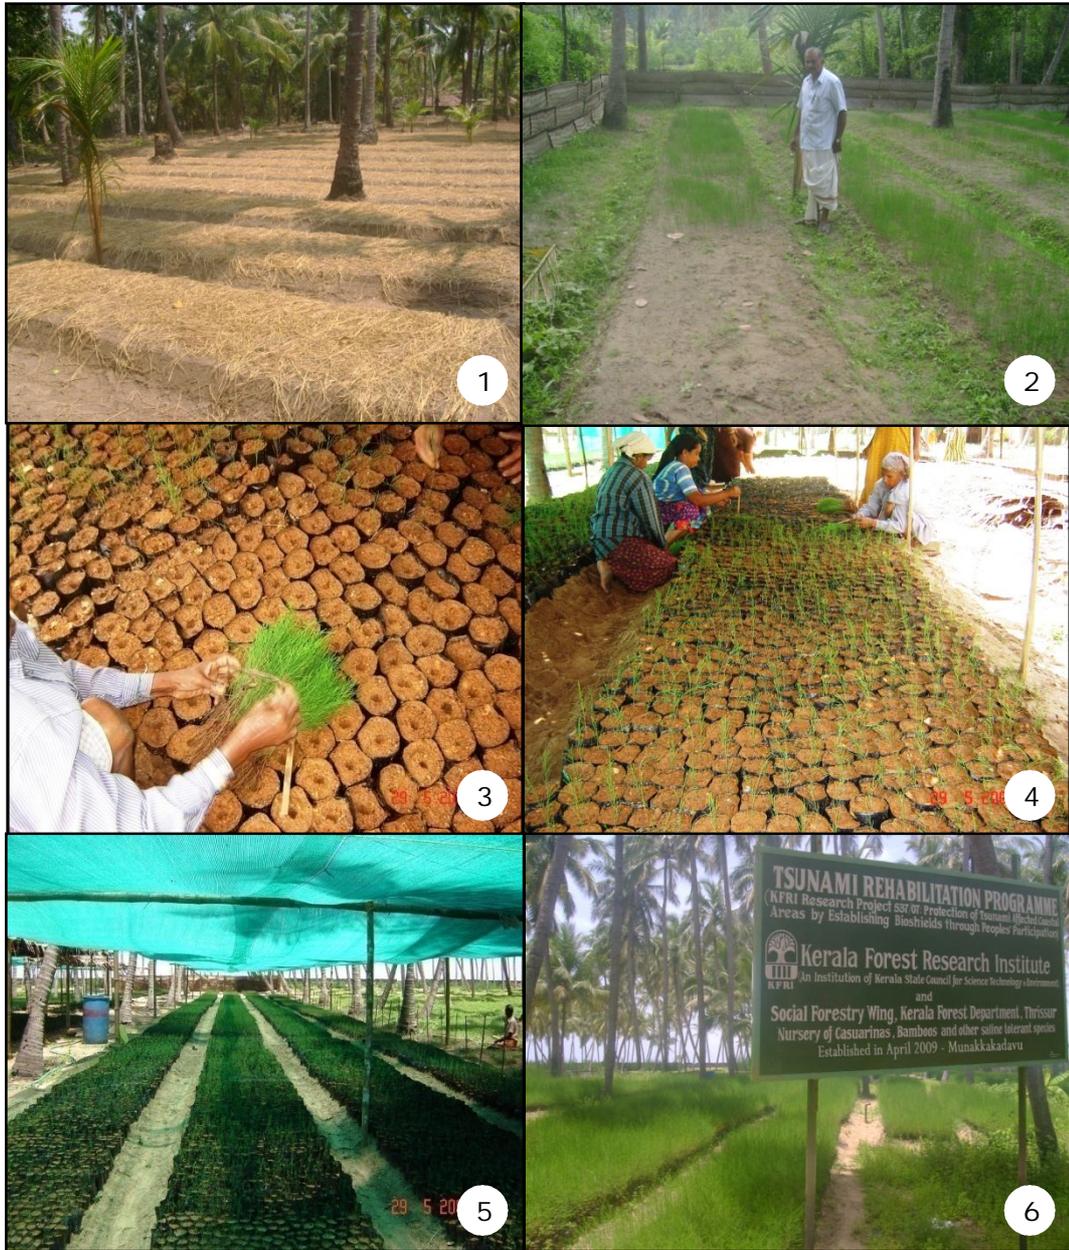
Plate 2. *Casuarina* nursery at Peringottukara. 1. Mother-bed: seeds sown and covered with hay 2. Germinated seeds after one month. 3 & 4 Stages of polypotting. 5. Polypotted seedlings 6. Seedlings one month after polypotting.

Casuarina equisetifolia: The nursery beds were prepared with equal portion of sand, soil and cowdung. Shade was provided with coconut leaves/nursery nets for one week. The nursery beds were mulched with hay till the seeds germinated (Plate 2). After about one month the germinated seedlings were transplanted to polybags (22.5 x 17.5 cm) with a mixture of soil, sand and cowdung (3:1:1) as potting medium (Plate 2). Watering was done twice daily with rose can for mother beds and with hose pipe after transplanting to polybags. Weeding was carried out as per requirement in both mother beds and in polybags. A mild dose of fertilizer was applied one month after potting in liquid form through rose can (urea – 1kg; groundnut cake – 5kg; cowdung – 10 kg diluted with 200ml of water). Some of the seedlings which were infested with *Cuscuta* sps. were removed

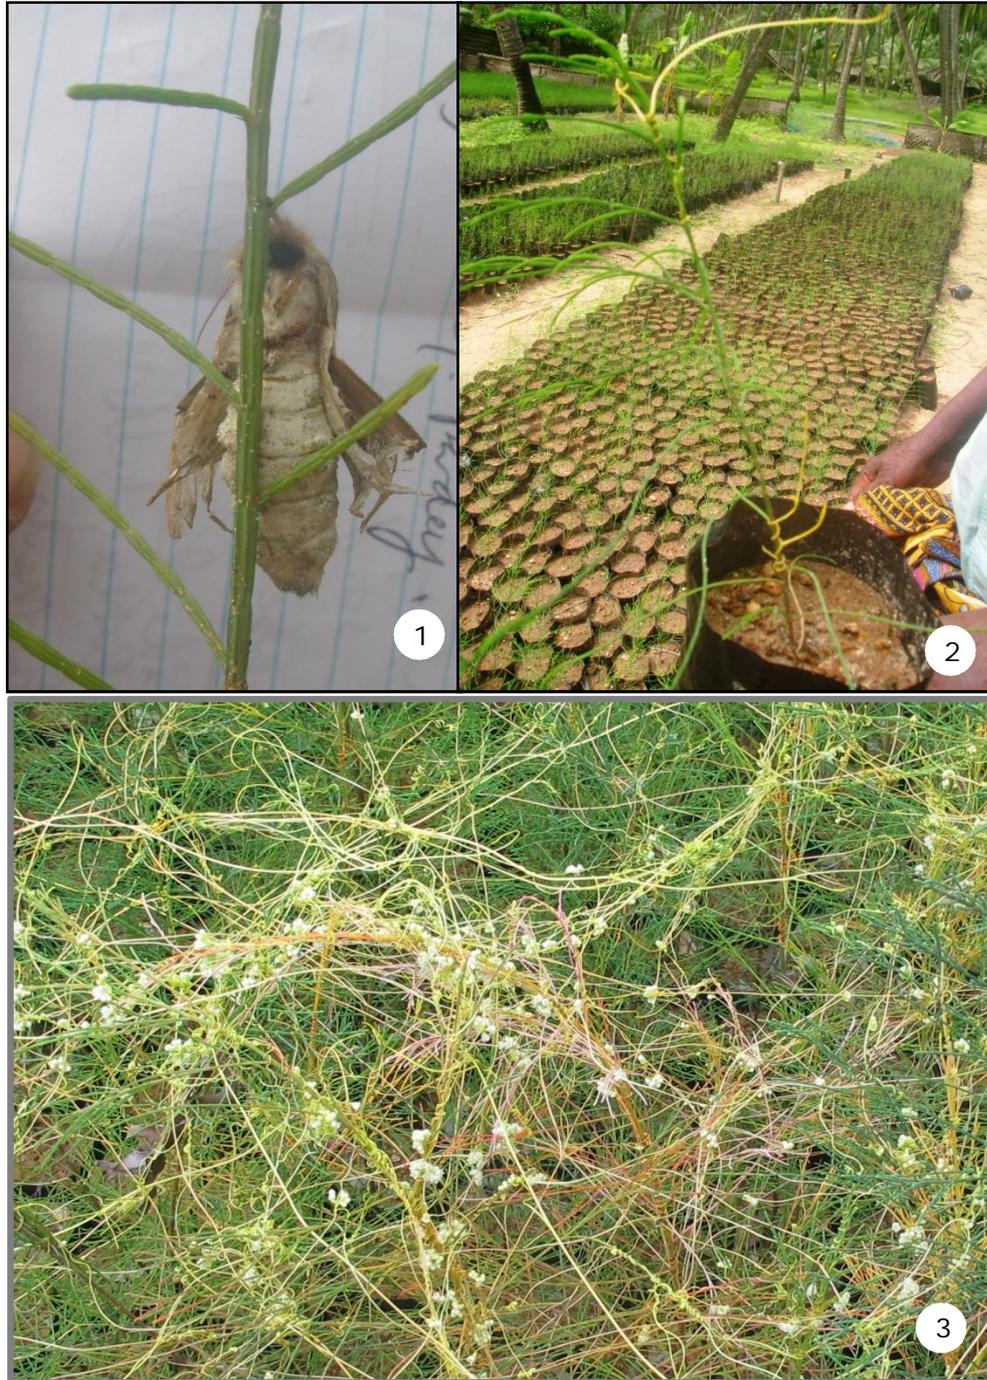
Plate 3. 1. Moth found on *Casuarina* seedlings 2&3 Seedling affected by semi parasite *Cuscuta* sp.

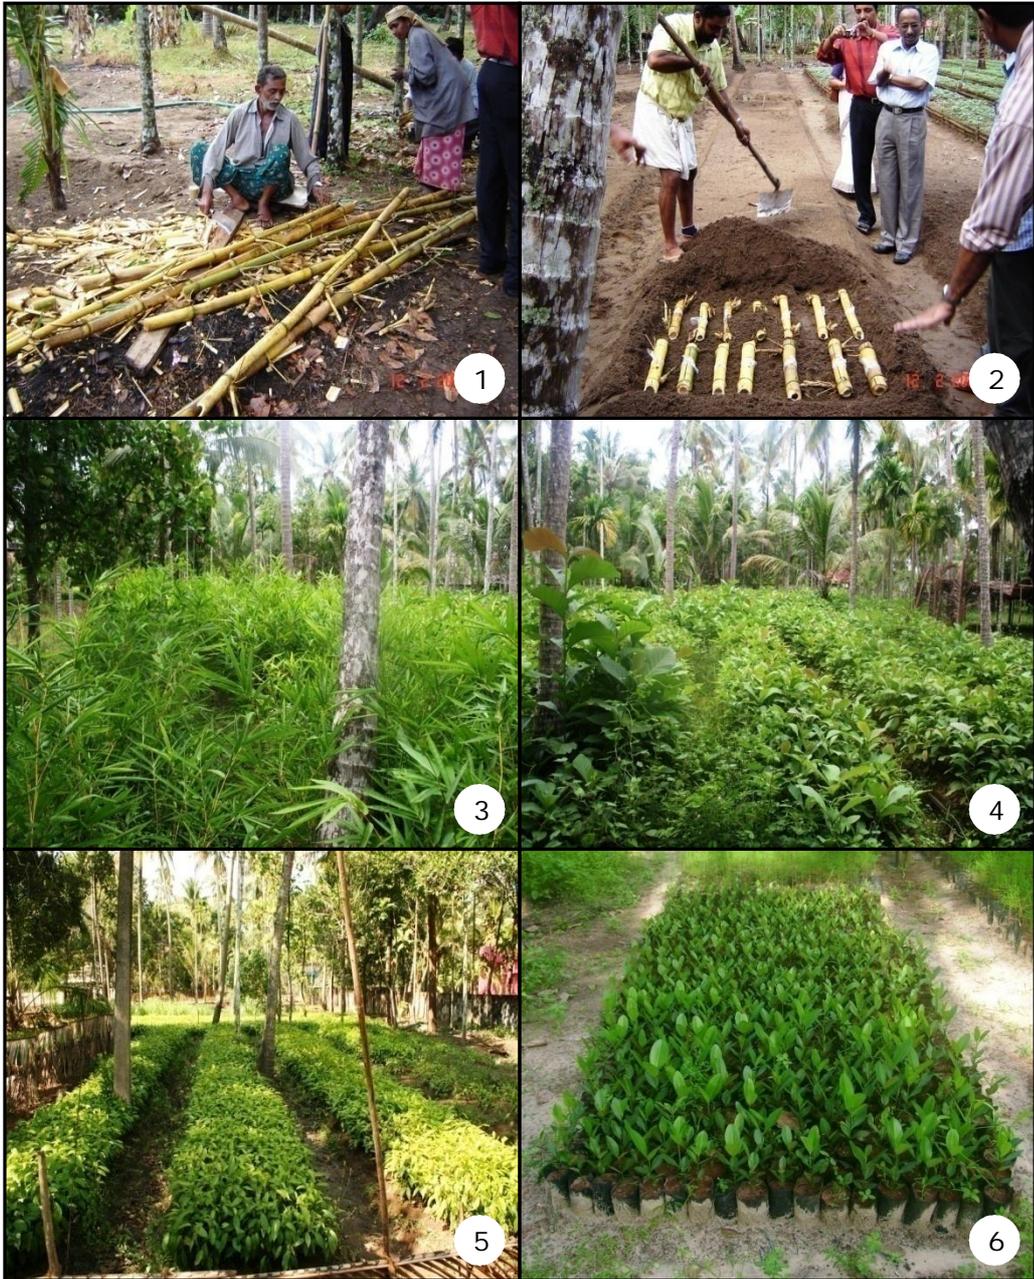
Plate 4. 1 & 2. Cuttings of bamboo used for propagation. 3. Nursery after two months 4. Seedlings of Teak 5. Mahogany 6. *Terminalia*

Bambusa striata* and *B. vulgaris: Planting stock of *Bambusa striata* (Yellow bamboo, Golden bamboo) and *B. vulgaris* (green variety) were produced by rooting culm and branch cuttings (KFRI, 1999). The mother clumps for collection of cuttings were selected from the healthy clumps growing in FRC campus, Velupadam and homesteads in Chittilappilly. Two-year-old culms (culm is one full bamboo from base to top) were extracted from mother clumps by cutting just above the first node. The leaves and side branches were trimmed without damaging the axillary buds. After shifting the culms to the nursery site, two-noded culm cuttings were prepared (Plate 4). The cuttings were treated with NAA 100 ppm (200 ml of the solution). The treated cuttings were planted horizontally in nursery beds. Profuse sprouting appeared first followed by natural thinning of sprouts retaining one to three dominant healthy sprouts. Slender roots developed within one month and rhizome development took place within three to six months.

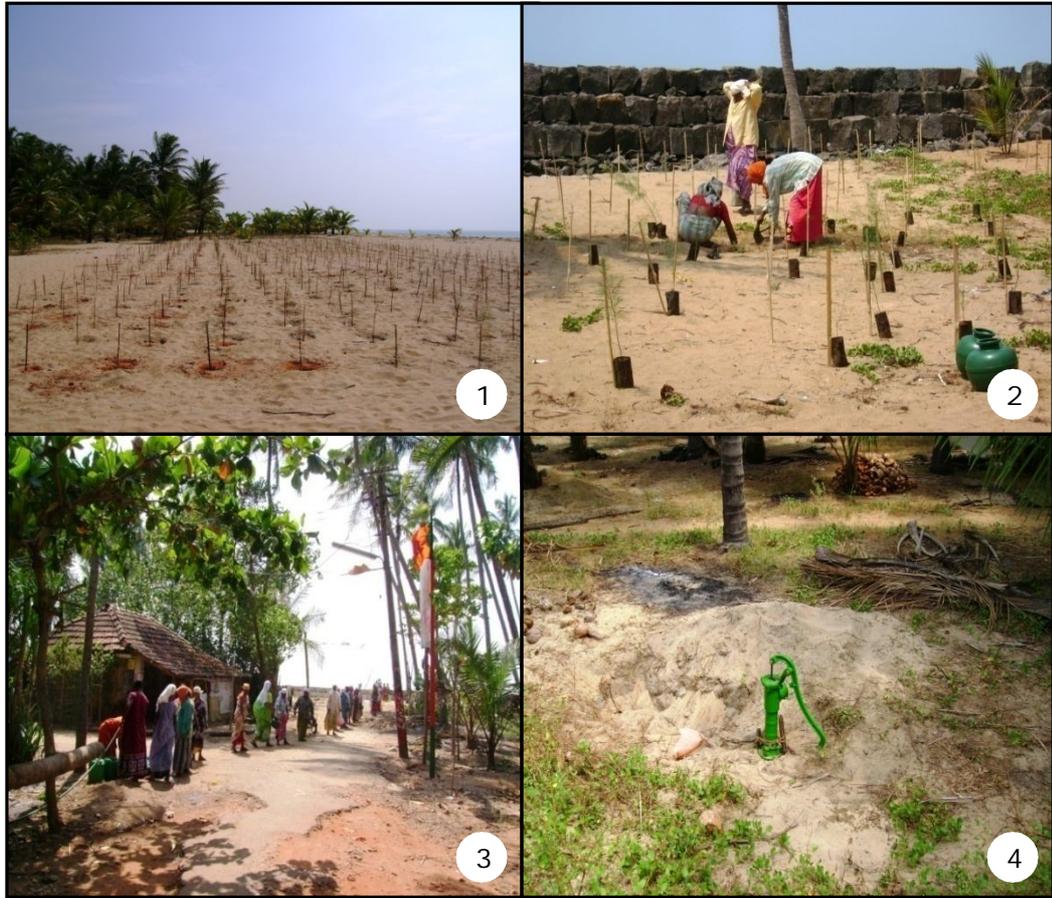
Plate 7. 1. A view of area aligned with bamboo stakes for planting 2. Planting process 3. Watering with participation of ladies under MGNREGS 4. Champ pipe installed by KFRl

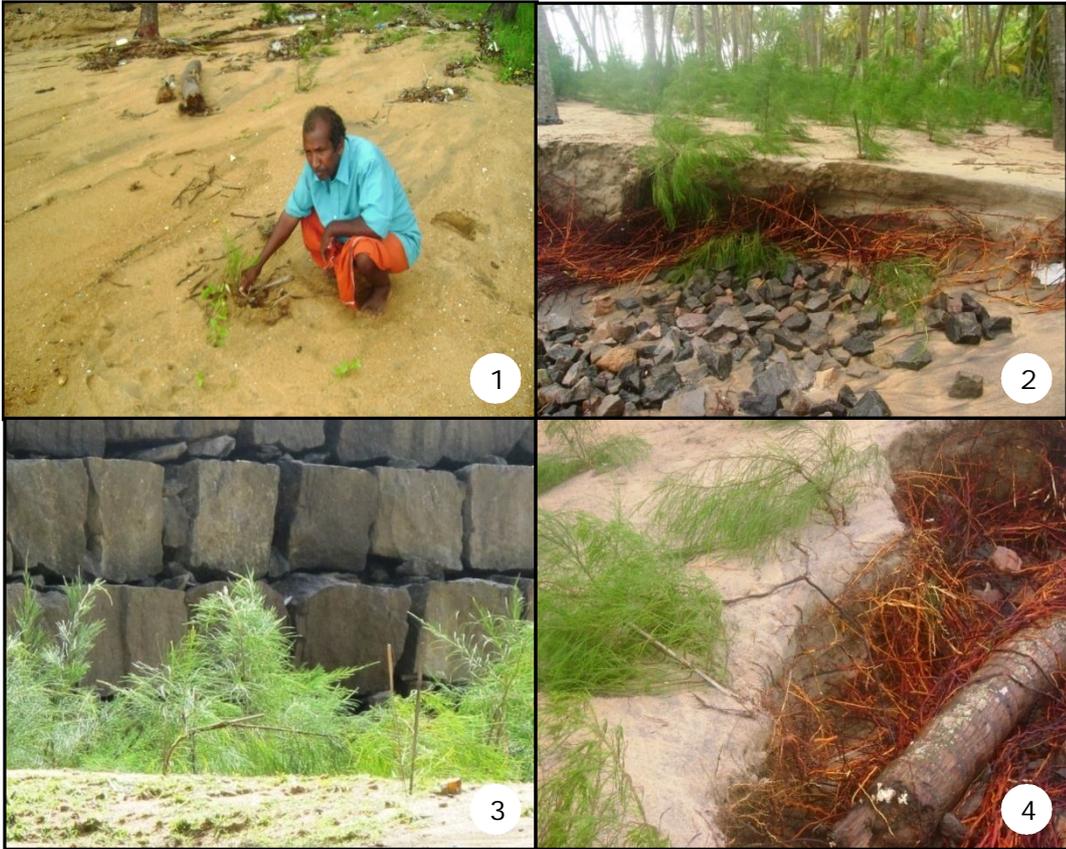
Plate 10. 1. Seedlings of *Casuarina* completely submerged under newly deposited sand. 2. Erosion of sea shore in planted areas of bio-shield. 3 & 4 Views of bending, breaking and uprooting of seedlings planted due to the force of waves.

The major problem was erosion and sand deposition over the planted seedlings. Sea erosion was observed in two ways. The first type was caused by breaking of the shore area to a height of about 2-4 m and along the coast; the casuarina seedlings and coconut trees were washed away. Breaking of the seedlings due the pressure of waves was also observed (Plate 8). The second type of erosion happened when the waves rose above the level of sea wall. Along with the back flow of salt water, sand erosion occurred resulting the formation of a narrow canal (Plate 9). The weaker areas of the wall were damaged ultimately resulting in the damage of the sea wall.

Another problem was the deposition of sand to a height of 1-3 m above the planted areas resulting in the complete submersion of seedlings (Plate 9 & 10). In many places the sea carried away the sand and in some other places it was deposited. In both areas parts of the bio-shields were damaged. It was very critical during the first year after establishment of bio-shield.
