Cost Effective Soil and Water Conservation – Establishment of a Demonstration Area with People’s Participation

Kerala Forest Research Institute

January 2006

Project Report

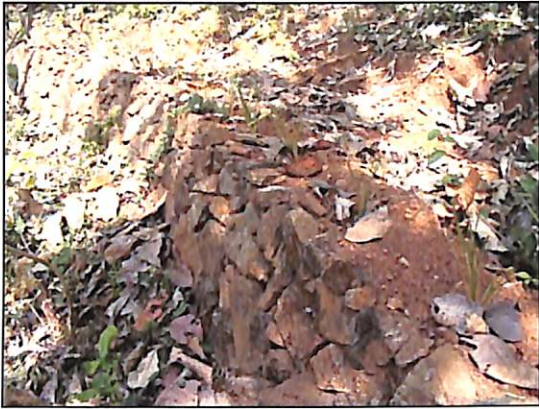
Plate 7. Contour bund with Vetiver

Grass slips were planted on contour bunds to strengthen them. The roots of grass have capability of binding soil and preventing erosion. Two species of local grass were used viz., *Vetiver* and *Cympapogon* (Plates 7-8).

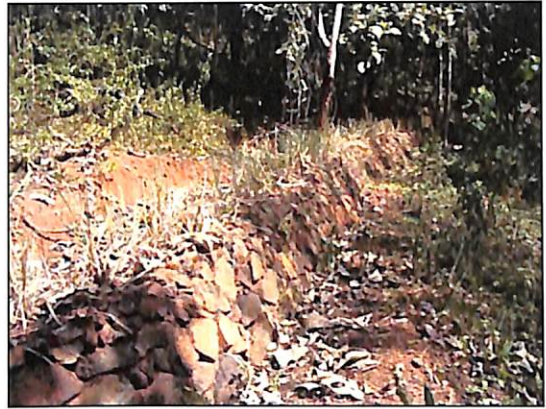
Plate 8. Contour bund with Cymbopogon

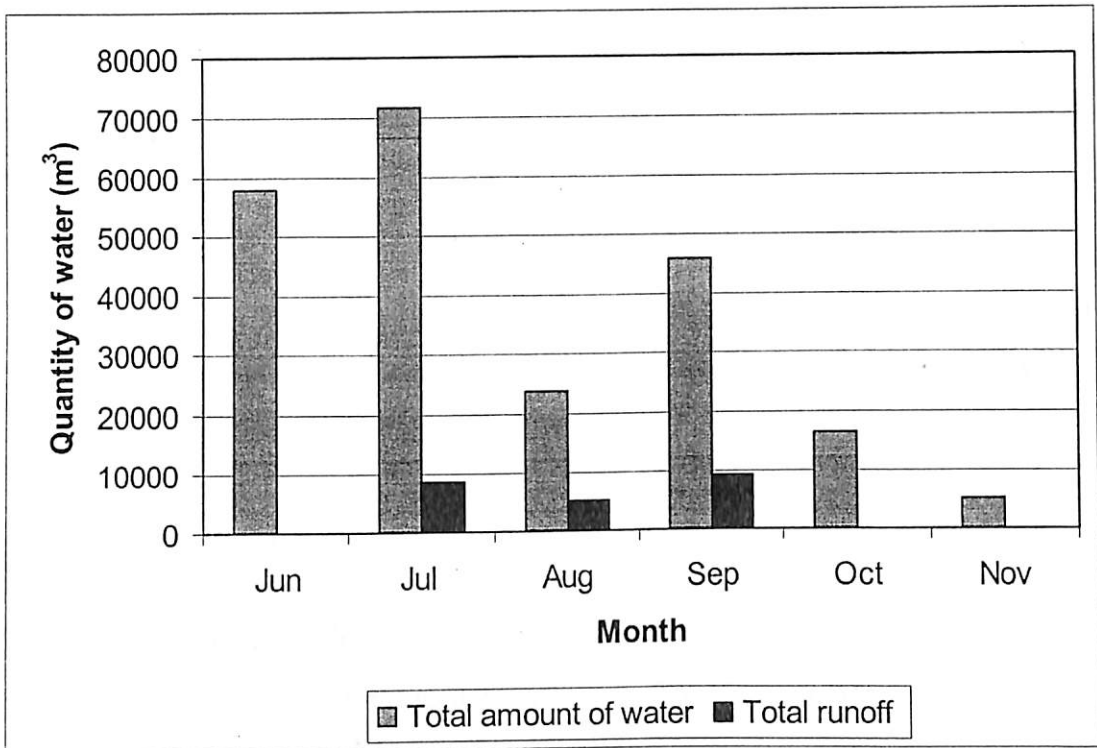
Fig 6. Rainfall and runoff

The relationship between run-off and rainfall (Table 6 and Fig. 6) indicates that run-off has been controlled to nearly 10.06% of the rainfall. It is interesting to note that during June 2005, when the rainfall was 723.66 mm, there was no run-off. This clearly proves that the water is being stored within the watershed by enhanced infiltration.

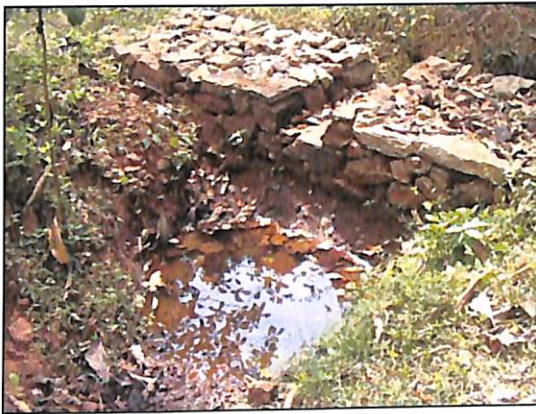
Plate 15. Water stored at check dam

A few springs in the upstream were rejuvenated (Plates 15 and 16) due to soil and water conservation efforts in the watershed. The enhancement of availability of surface water (streams, springs, etc) has drastically increased the biodiversity status of the model watershed (Plate 17) in comparison with control. A dramatic increase in the presence of the following groups has been observed: birds, snakes, deer (ungulates) etc.

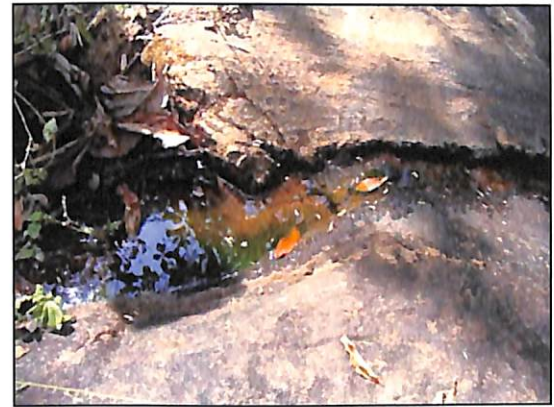
Plate 16. Water flow at upstream
